Ultra-Deepwater Production Systems Technical Progress Report

October 1, 2003 - September 30, 2004

**K.L. Smith, ConocoPhillips Company, Houston, Texas and
M.E. Leveque, ConocoPhillips Company, Houston, Texas**

Report title: Technical Progress Report-Annual

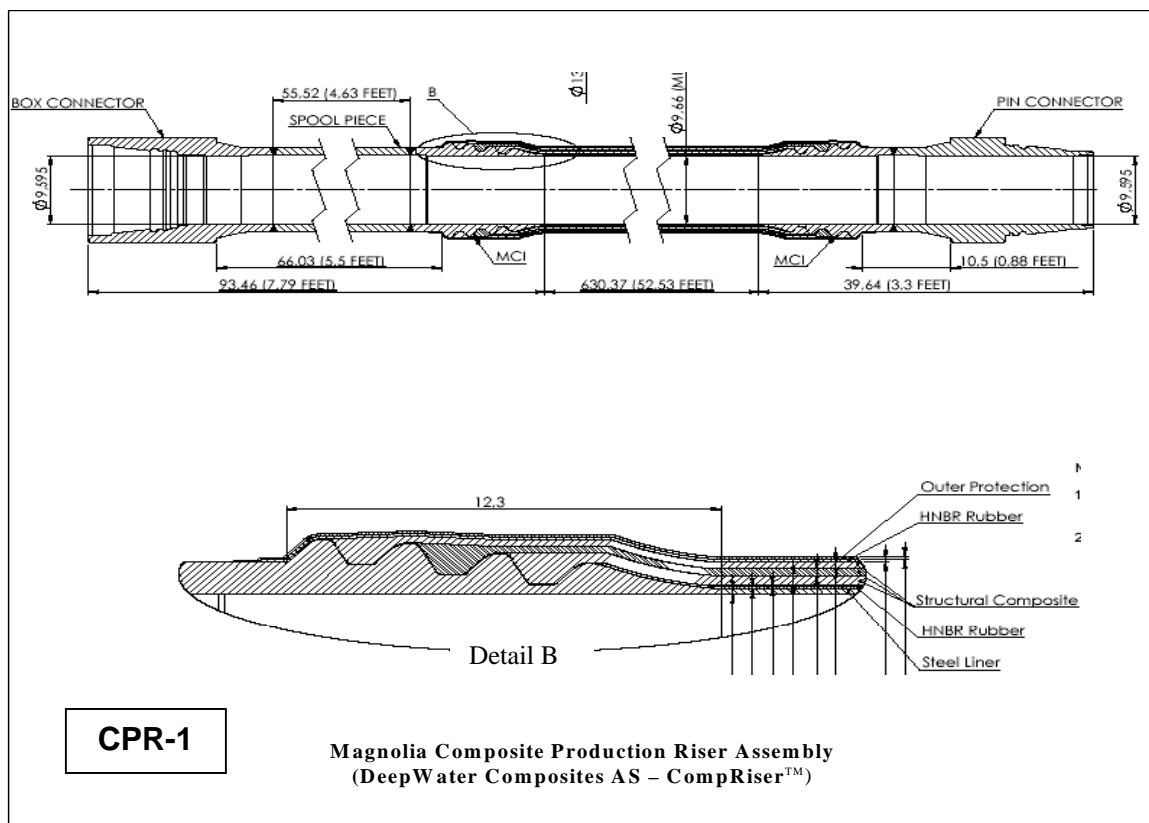
As of the start of this review period, an initial composite joint design had been established, and is illustrated below (Fig. CPR-1).

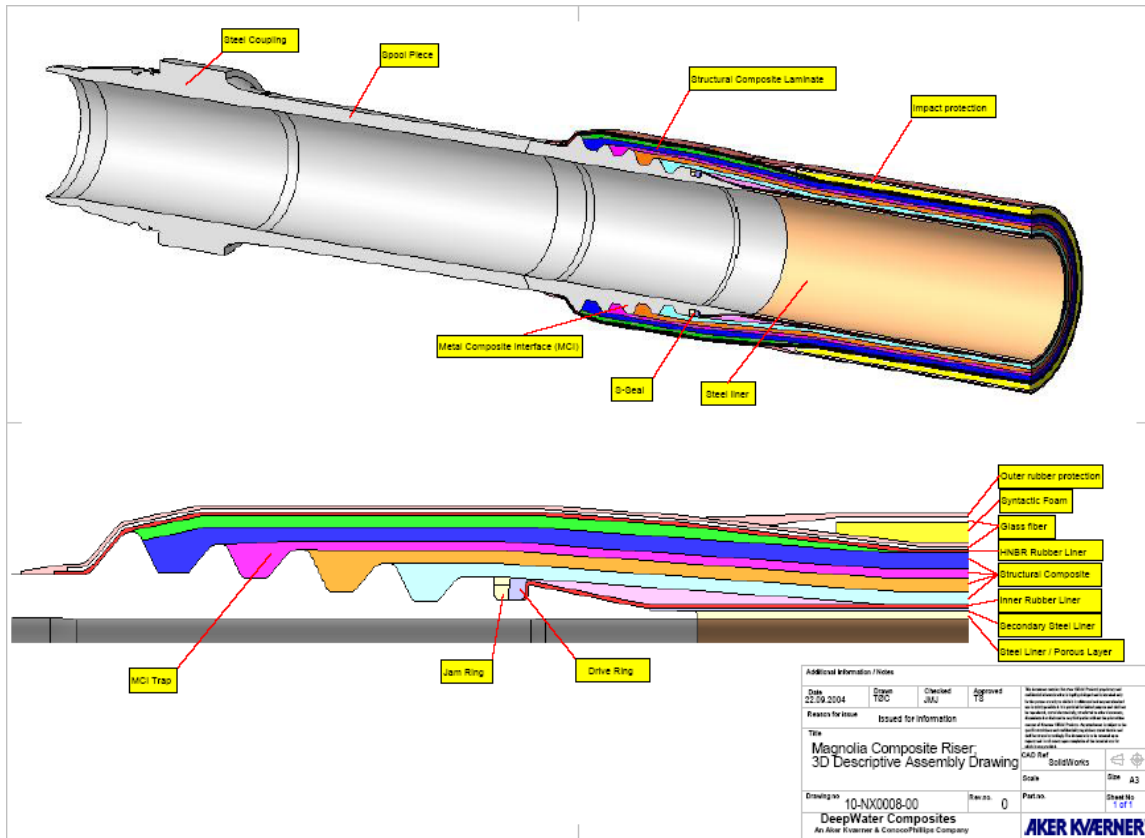
CPR-2 – Composite joint section (pin end)

Considerable effort was expended over the period under review to build and calibrate a new FEA model of the composite joint, to better understand the complex interactions between the steel and composite parts. The resulting final design is broadly illustrated below. Note that the composite structure actually consists of alternating multiple hoop and axial fiber layers, as well as fiberglass layers introduced for increased impact resistance.

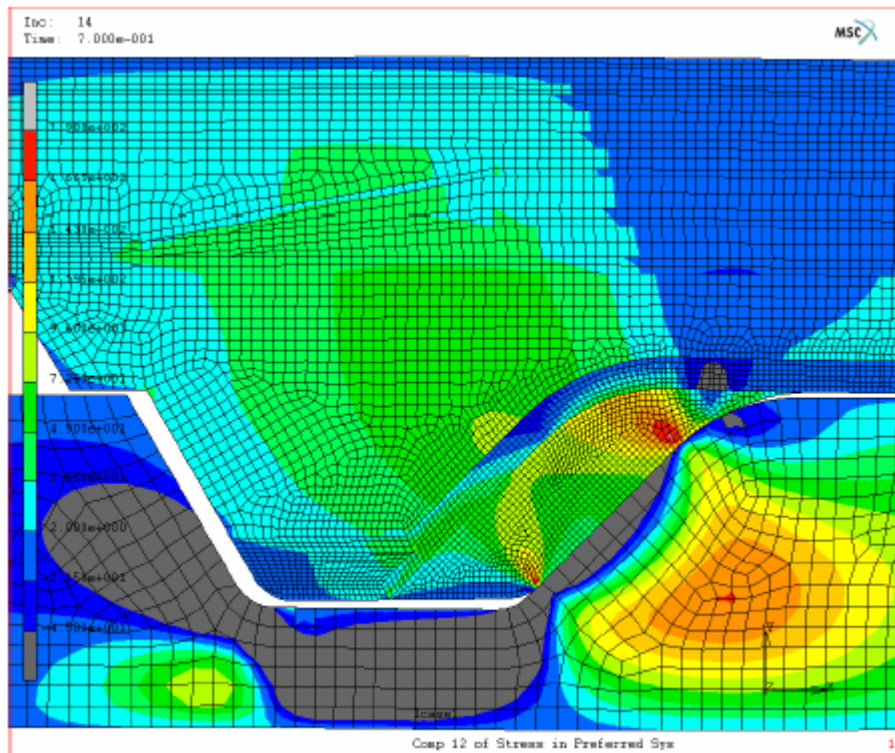
CPR-3 - Example of FE model mesh

In addition to the FEA work performed by DeepWater Composites, ConocoPhillips also independently contracted to have the original third-party FEA work (initial design) revised and upgraded to reflect the design changes. This independent FEA, using different computer modelling software, essentially confirmed the results obtained by DeepWater Composites.

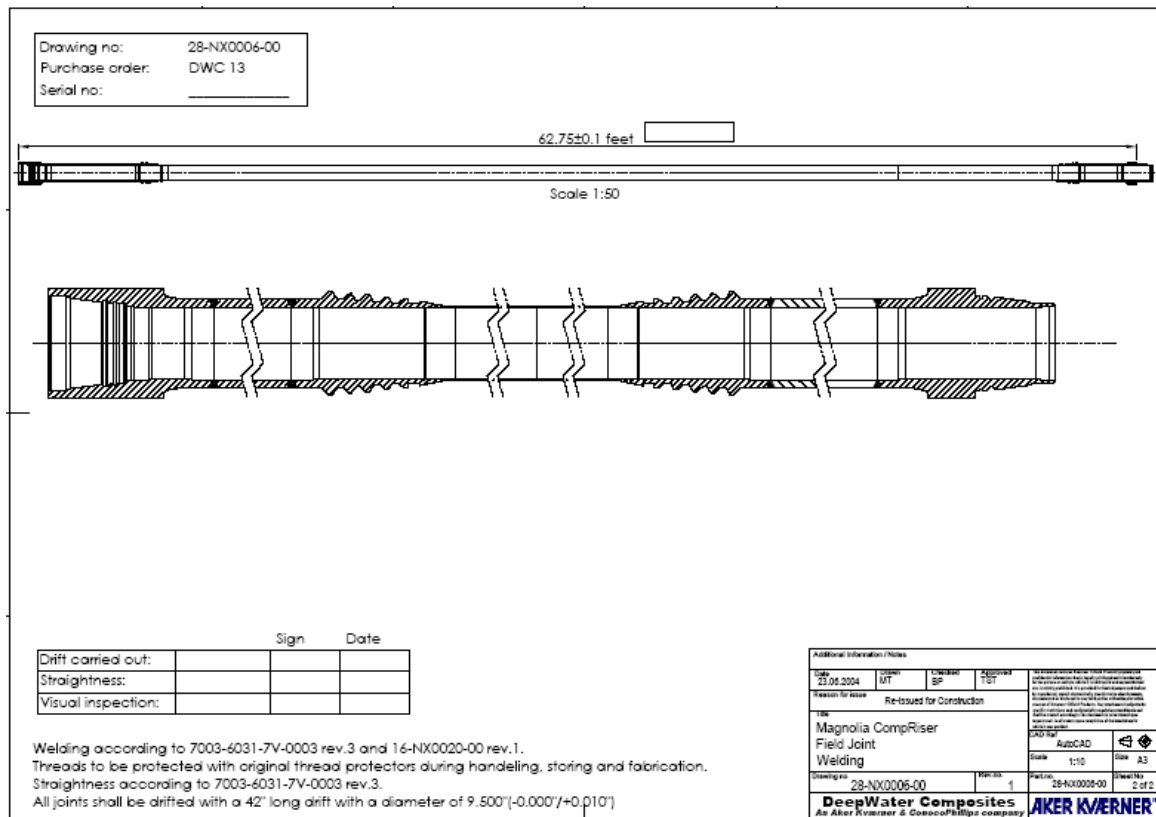
CPR-4 – Metal assembly

Field joint metal assemblies were fabricated and the first full scale joint (CLT-7) was completed, except for the outer protective layers, during the period under review. Below is a drawing showing the metal assembly for a full joint (CPR-4)

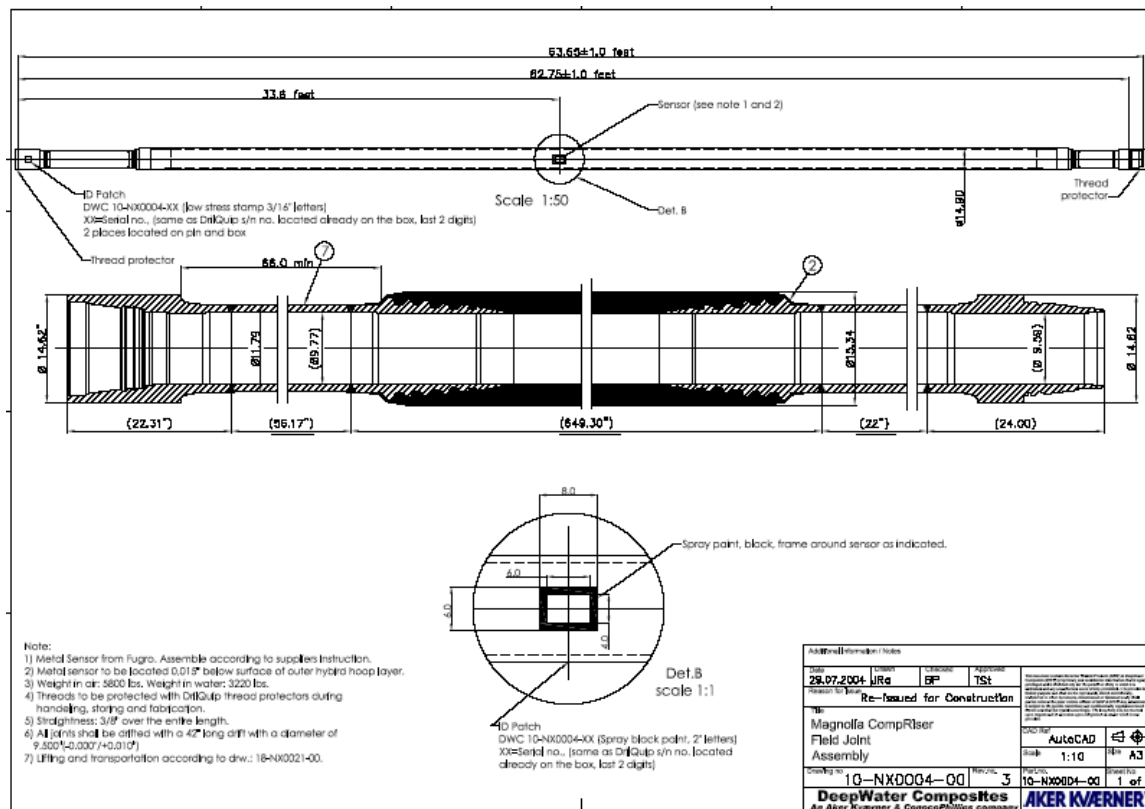
CPR-5 – Completed composite riser joint

The final product is depicted in the drawing below (CPR-5).

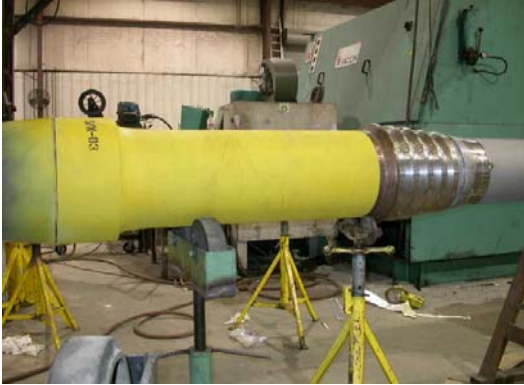
CPR-6 - Pin/MCI assembly fitted to primary liner

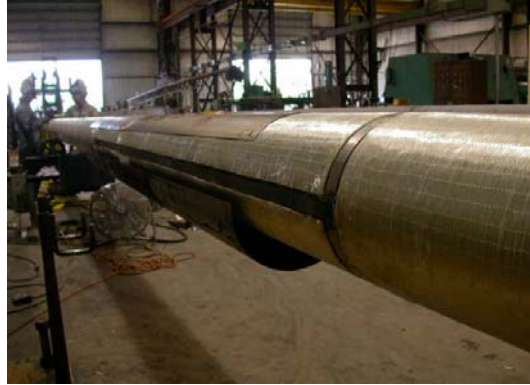
CPR-7- Secondary liner section being wrapped over primary liner, dry fiber and backing strips

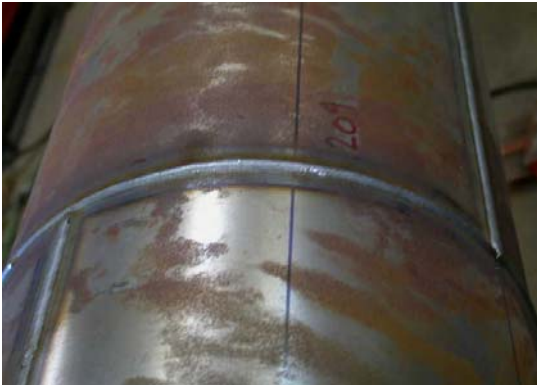
CPR-8 - Secondary liner welds

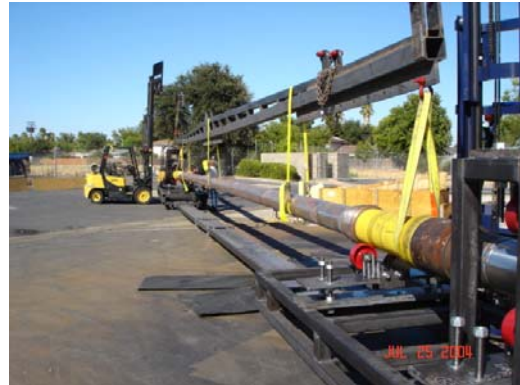
CPR-9 - Completed metal assembly loaded onto winding cart

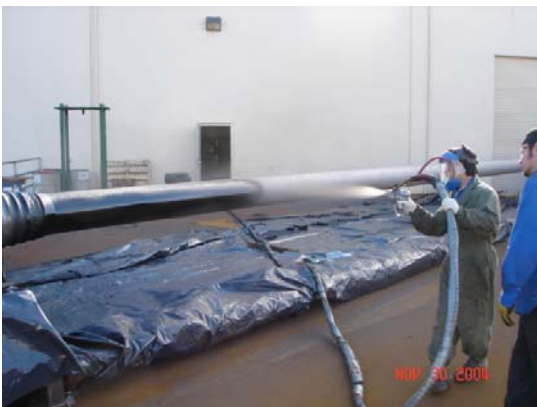
CPR-10 - Spraying Polyurea layer

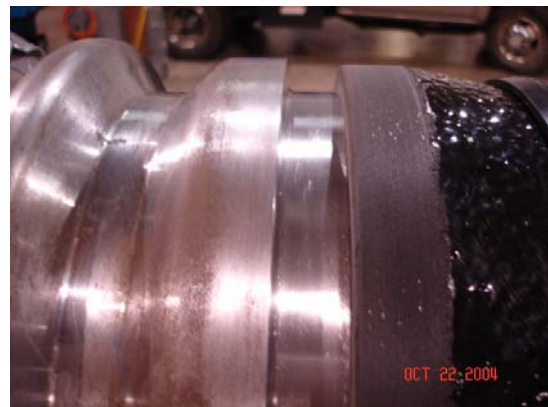
CPR-11 - Polyurea machined into seal groove

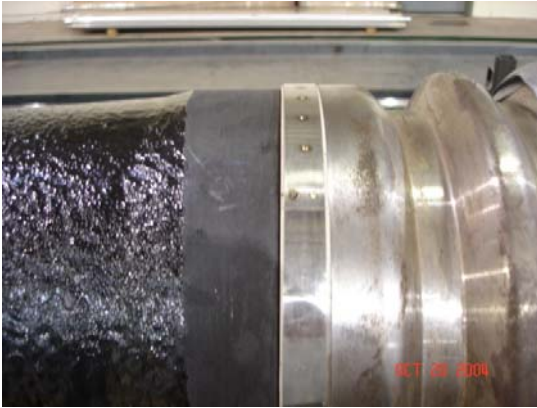
CPR-12 - Rubber seal clamped in groove

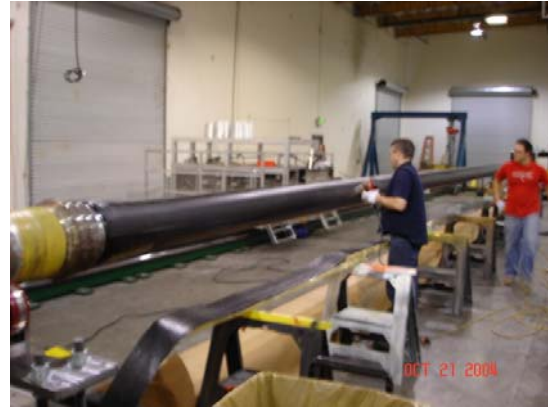
CPR-13 - Pre-preg axial fiber strips applied

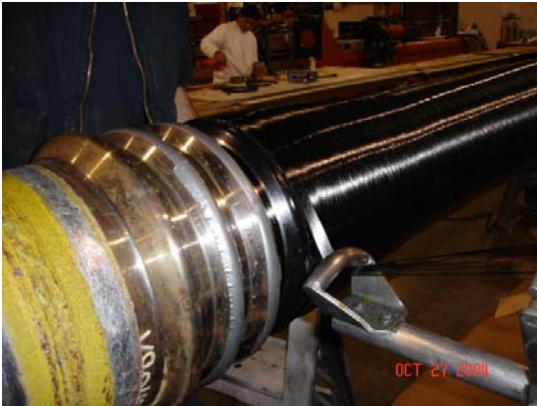
CPR-14 - Hoop fiber filament winding

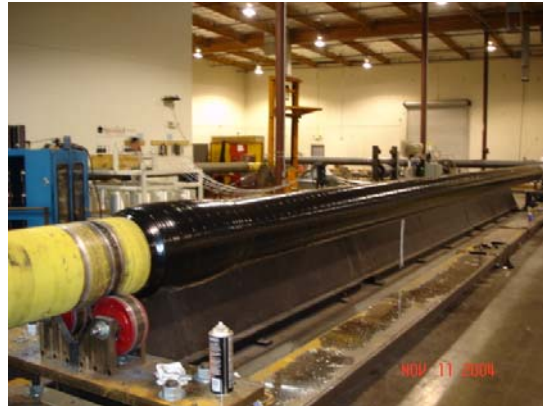
CPR-15 - Composite application complete

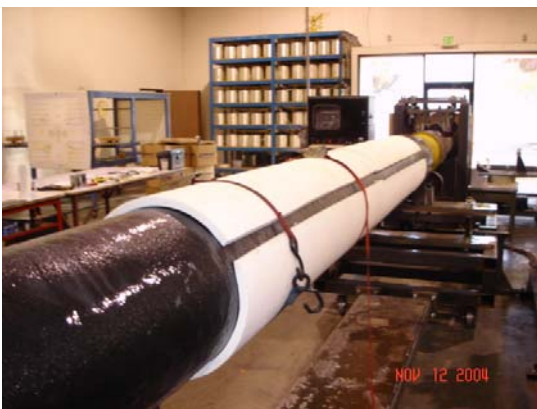
CPR-16 - Impact protection foam installation

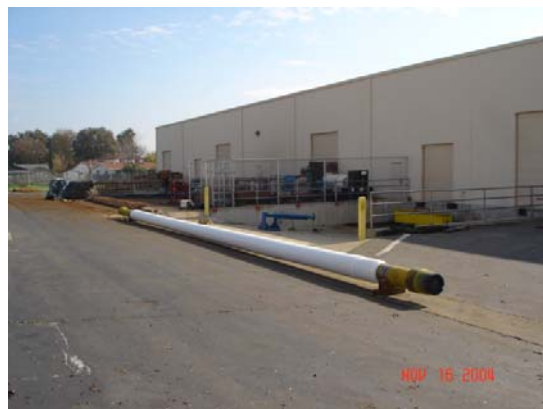
CPR-17 - Completed joint

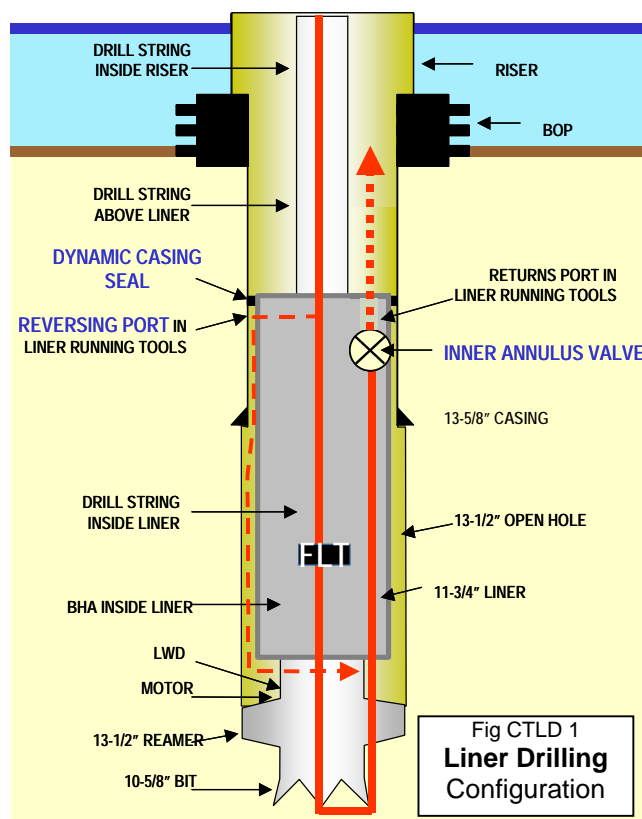
There are two other requirements that impact the design: the desire to sweep the open hole annulus of any cuttings, debris or influx materials, and the need to address a well control incident when the liner and drill string are across the BOP stack. To meet the first requirement, a reverse-circulation port was built into the liner running tool, and it is ported to divert a small portion of the mud from the drill string down the backside of the liner. This can only be done with the introduction of a seal at the top of the liner hanger that forces the

mud to go down the tight annulus rather than directly out above the liner top. This is Tesco's "Dynamic Casing Seal™" (DCS) element. To meet the second requirement, Baker developed an "Inner Annulus Valve™" (IAV) had to be built into the running tool that allowed rapid closure of the liner by drill pipe annulus when needed. This isolates the drilling riser from the conduit through the liner to the wellbore below the blowout preventer.

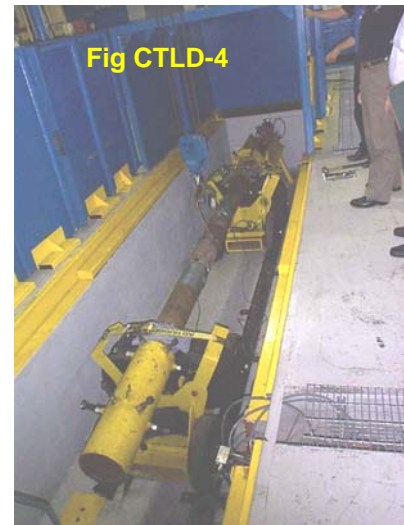
Of concern were the fatigue consequences on the liner while drilling, especially in the connector area. The connectors chosen were flush or near-flush OD: Hunting's SLSF and Grant-Prideco's DWC-DS/A. To test this, a "bouncing betty" was used (Fig CTLD-4). It is an oscillating machine into which pipe can be placed and rotated with induced lateral loads, creating a curvature in the center of the pipe.

Three samples of each connection were tested to failure under an induced stress equivalent to a relatively severe 5°/100' dogleg severity. The samples all failed between 2.7 and 6 million cycles: in all cases, at least 10 times the goal. Both were deemed acceptable for use offshore.

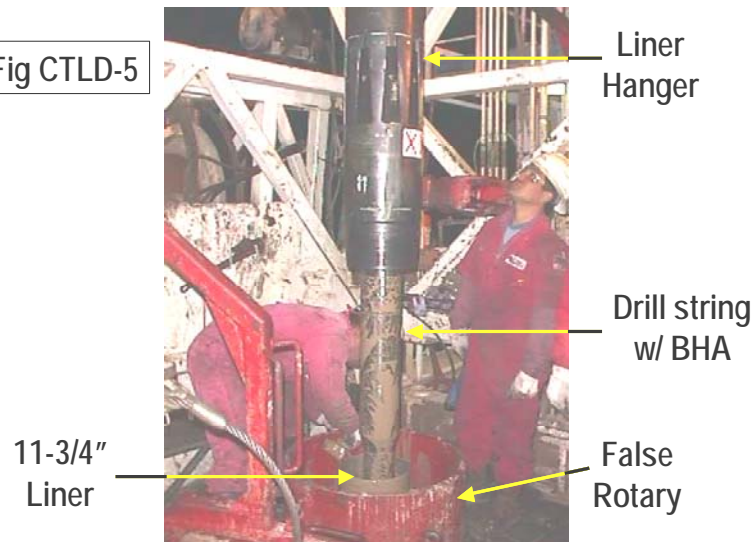
Fig CTLD-5

The liner hanger, liner hanger running tool and DCS assembly were picked up and made up into the liner. The BHA included the downhole drilling dynamics package (Baker's CoPilot™ tool) and annular pressure equipped MWD. These devices would be used to measure any vibrations and the pressures necessary to understand the hydraulic characteristics.

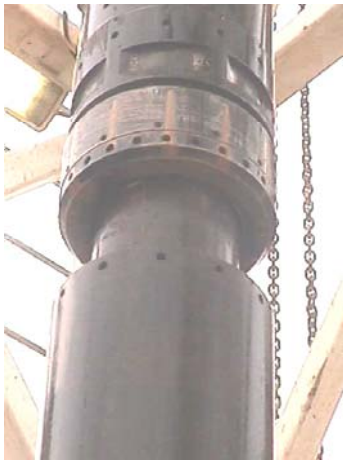
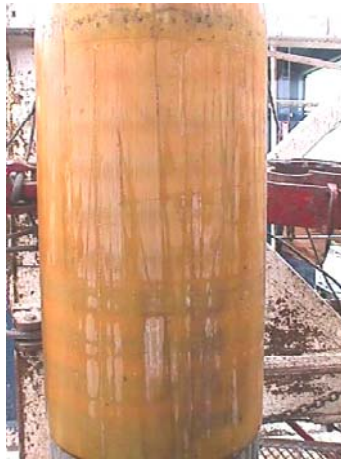
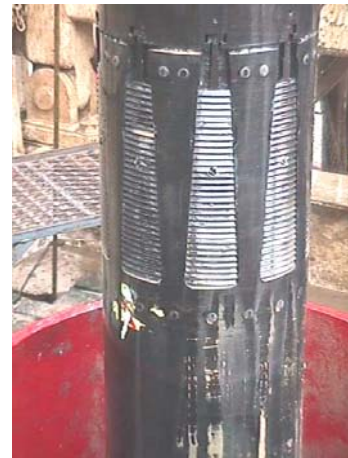
Fig CTLD-6

Mud Filter of DCS

Translating Seal
Of DCS

Liner Hanger
Slips

After pulling out the assembly and returning it to the shop, the ball was dropped and the liner hanger set, proving that the mechanism is robust. External inspection indicated no significant wear anywhere (Fig CTLD-6). Upon tear-down, however, there were some negative findings that were addressed. The most significant was the failure of a seal in the liner hanger running tool. This allowed mud into the running tool, and the barite in the mud settled out within the tool, locking up some of the mechanism (Fig CTLD-7). This was redesigned so that the mechanism was contained in a pressure-balanced oil bath. The DCS seal had several missing wear inserts (Fig CTLD-8), so the shape of these inserts was changed from cylindrical to spherical. The liner was also inspected, and several joints required recutting.

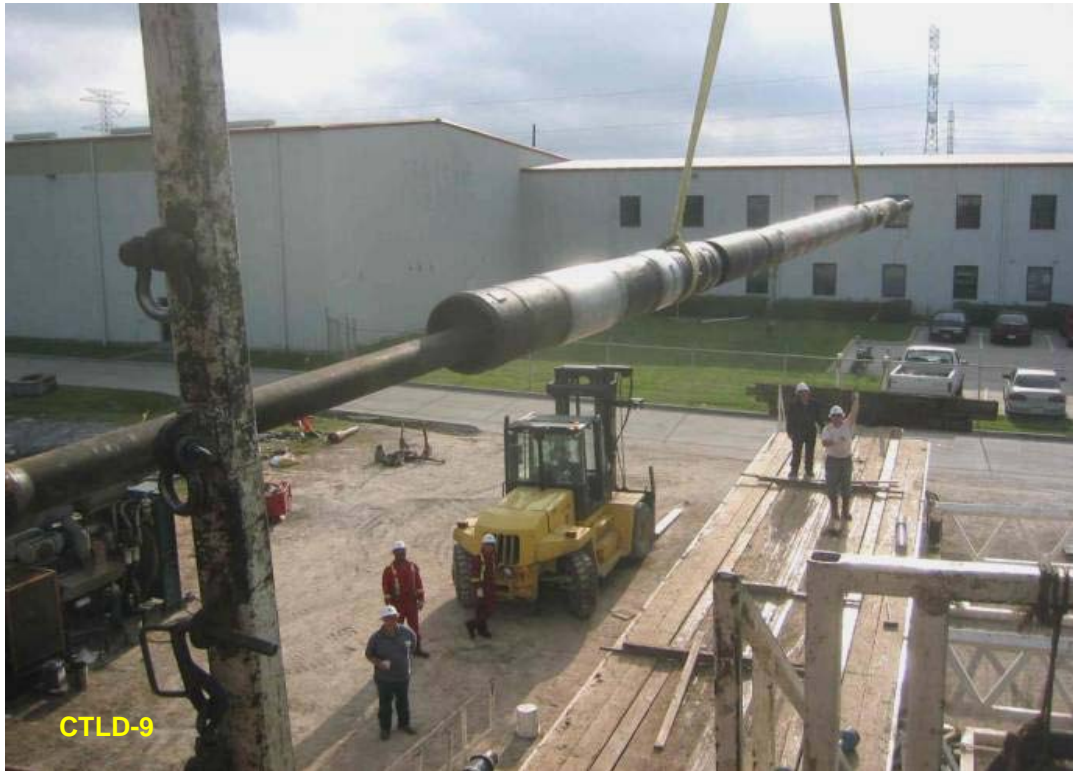
After running the 11-3/4" liner in the well, the same BHA was picked up and run through the liner as in the cased hole test, except that the specially developed 13.5" Smith Rhino Reamer and a mud motor were picked up to allow the hole enlargement for the liner at relatively low liner rotation speeds. The liner hanger running tool, liner hanger and DCS assembly were picked up. (Fig CTLD-9).

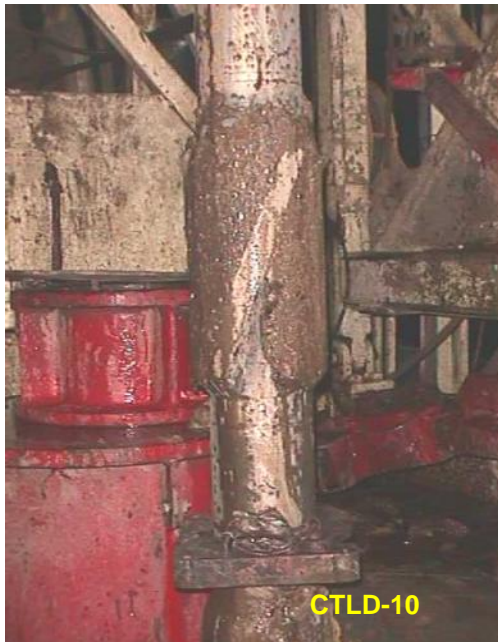
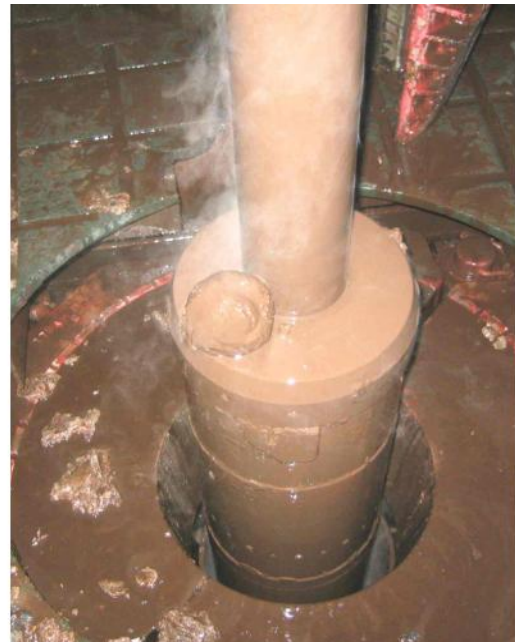
The tools were totally plugged up with gumbo, as expected. The outside of the tools was clean, reinforcing the fact that the reverse circulation feature works in keeping the backside of the liner clean (Fig CTLD-10).

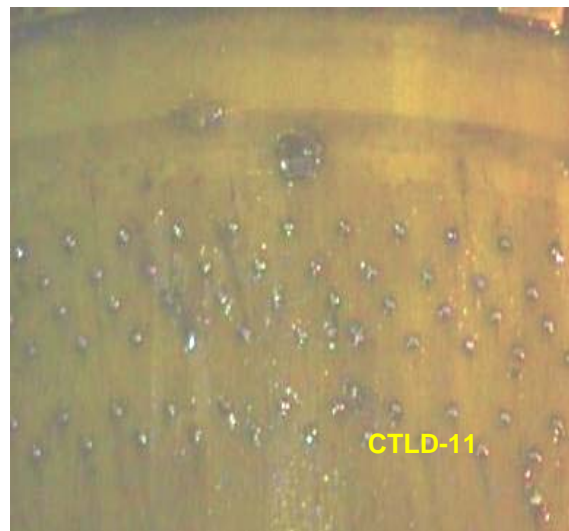
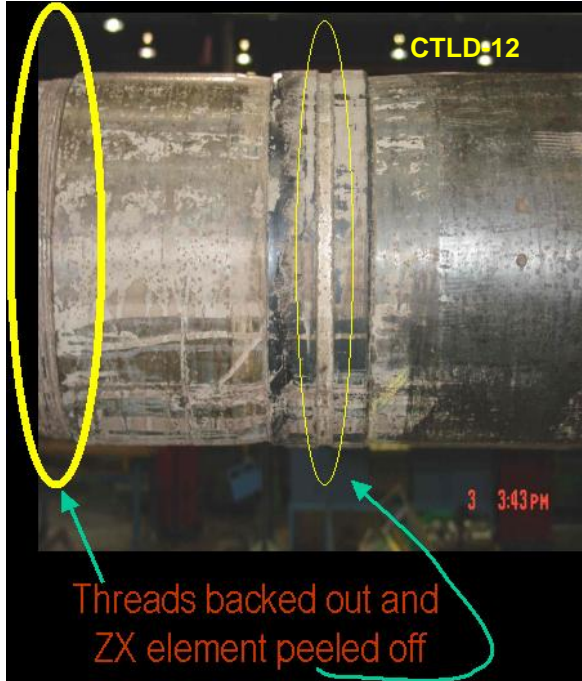
- The changes to the inserts in the DCS element worked perfectly; none was lost (Fig CTLD-11).
- A ZX seal element had been peeled off through contact with the casing wall. The cause was the translation of the setting cone when the vibrations sheared the set pins (Fig CTLD-12).
- There was erosion on the inside of the outer closing sleeve over the reversing port. This occurred because the vibrations allowed the set pins holding the sleeve in place to vibrate loose, and the sleeve began closing on its own across the reversing jet.
